# Structural Health Monitoring of Steel Tower Structure Using Long-term Vibration Sensing with High-precision Accelerometers and MEMS Accelerometers

**Abstract** - Many steel tower structures built in Japan are aging and are increasingly at risk of collapse in the event of typhoons or major earthquakes. At the same time, it is difficult to proceed with rebuilding such aging structures with limited budgets and manpower, thus there is a need to monitor the health of the structures, and to equalize and facilitate the rebuilding work. For this purpose, it is necessary to make full use of sensing technology to diagnose deterioration in order to accurately assess the condition of steel tower structures. In this study, sensors were installed at multiple locations on an actual steel tower structure, and measurements were taken over a period of nine months. Data was measured and saved for five minutes, centered on the time when the maximum Root Mean Square (RMS) value of acceleration occurred each day. There have been no other studies in which measurements were taken and analyzed at the time when the maximum vibration occurred each day, with almost no missing data, over several months of c

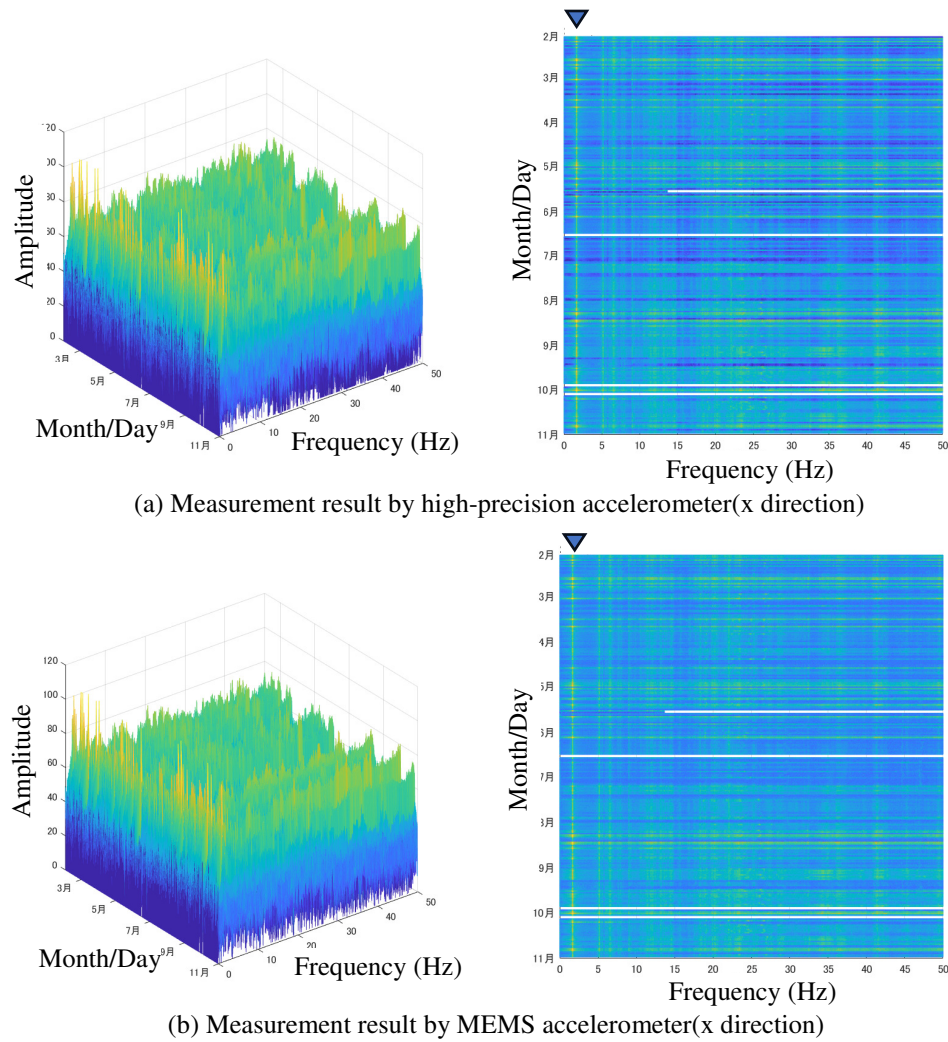
Figure 10. Fourier spectra of measured data at the top of the tower obtained by high-precision and MEMS accelerometer (x direction).

Figure 10 shows the Fourier spectra of the measured data (x-direction) at the top of the tower by the high-precision accelerometer and MEMS accelerometer during the measurement period. As shown in Table II, MEMS accelerometers have a lower noise density performance than high-precision accelerometers, making it difficult to

accurately measure small accelerations. Therefore, when comparing the right diagrams in Figures 10(a) and (b), MEMS accelerometers gave a lower overall clarity of the diagram. However, the peaks indicated by ▼ were still captured in the same manner as those of the high-precision accelerometers, and it is possible to discriminate natural frequencies as an indicator of damage risk.
